FRACTURE IN STEEL BRIDGE PIERS DUE TO EARTHQUAKES

Abstract: The great Hanshin Earthquake of January 17, 1995 caused serious damage to various civil structures never before experienced. A particular emphasis is placed on the fracture in steel bridge piers, and the results of studies up to date are reviewed in this paper.

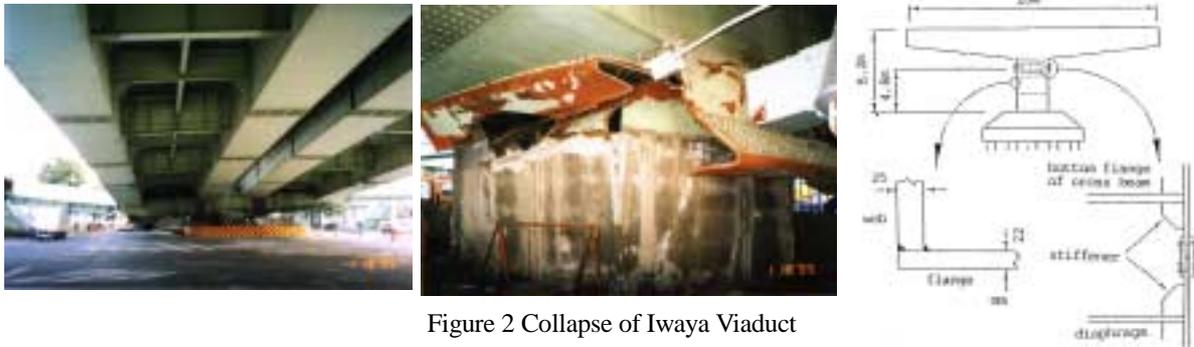
These were the steel bridge pier shafts at Iwaya Viaduct (Figure 2) on the national highway No.43 and Tateishi Viaduct on the Hanshin Expressway. According to the report of the investigation committee, the damage mechanism of the pier shaft at Iwaya Viaduct is “estimated to have been due to

the occurrence of local buckling deformation of panels between diaphragms including splice plates, as deformation grew larger so that corner welds at this parts began to be torn, and load bearing capacity for supporting vertical force became lost and the collapse occurred directly below in the end.” This means that the cause was breaking of vertical stiffeners at field-joints with high strength bolts, but according to normal thinking in design, vertical stiffeners need not made continuous at this detail. However, the sudden change in rigidity due to the stiffeners being broken, and the stress concentrations at stiffener ends may be said to be cases showing that they can be causes of failure.

Figure 2 Collapse of Iwaya Viaduct

Corner welds are so-called stitch welds which are for the purpose of assembling members but do not expect loads to be transmitted. Therefore, these corner welds are composed of partial penetration welds and internal fillet welds except in the region of beam-to-column connections. It is conceivable that if the joints had been strong, it could not have led to such collapse. By making these corner welds as full penetration welds, it is possible for the strength to be increased more than the strength with the partial penetration welds and fillet welds detail actually used here. However, what is of importance is that in failure of corner welds this time either the insufficiency of weld size or the root faces as incomplete penetration zone remaining due to partial penetration was involved as cracks.

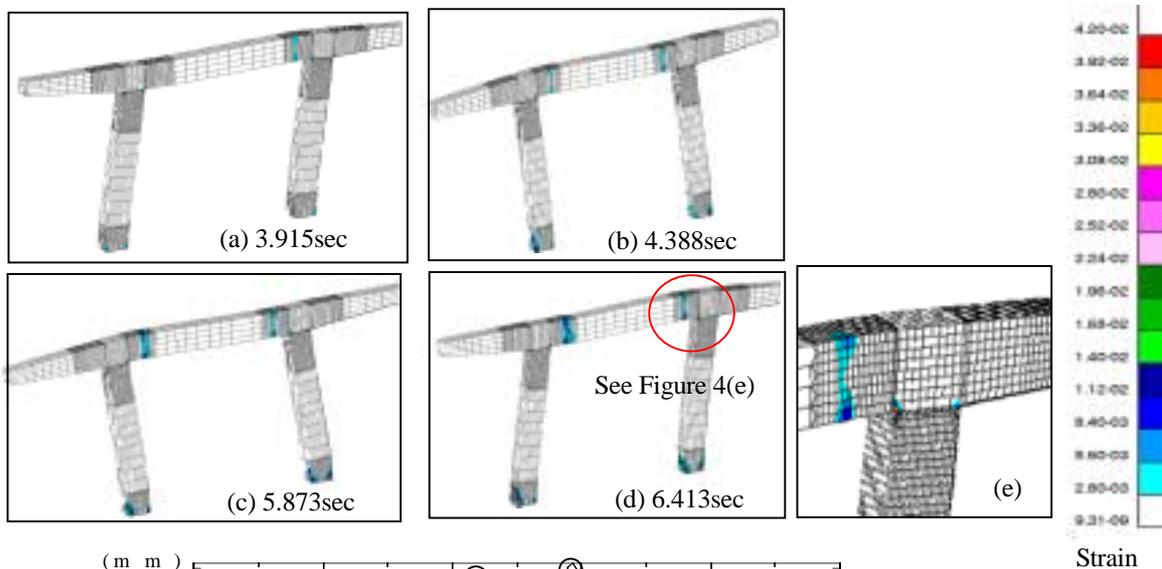
Figure 4 shows the representative result of the FEM analyses. In Figure 4, the time history of the displacement at the center of the beam upper flange was shown representatively, and the change of the deformations and the distributions of plastic equivalent strain were presented. As seen in the Figure 4, at two portions in the beam close to the beam-to-column connections, large plastic strain due to local buckling was occurred locally. Actually, the portions are just at the locations where the connections are there and the thickness of the plates is drastically changed. Especially, large plastic strain occurs at the corner joints of the beam. In contract, in the beam-to-column connections, no buckling occurs because of the large plate thickness due to the consideration in the elastic design of the local stress concentration by the shear-lag phenomenon. However, it should be noted that at the corner of the beam-to-column connections, large plastic strain occurs locally as shown in Figure 4(e) and that the local strain concentration can be one of the main causes of brittle fracture during earthquakes.

Figure 4 Dynamic FEM Analysis Results of A Steel Bridge Bent (JR Takatori Wave)

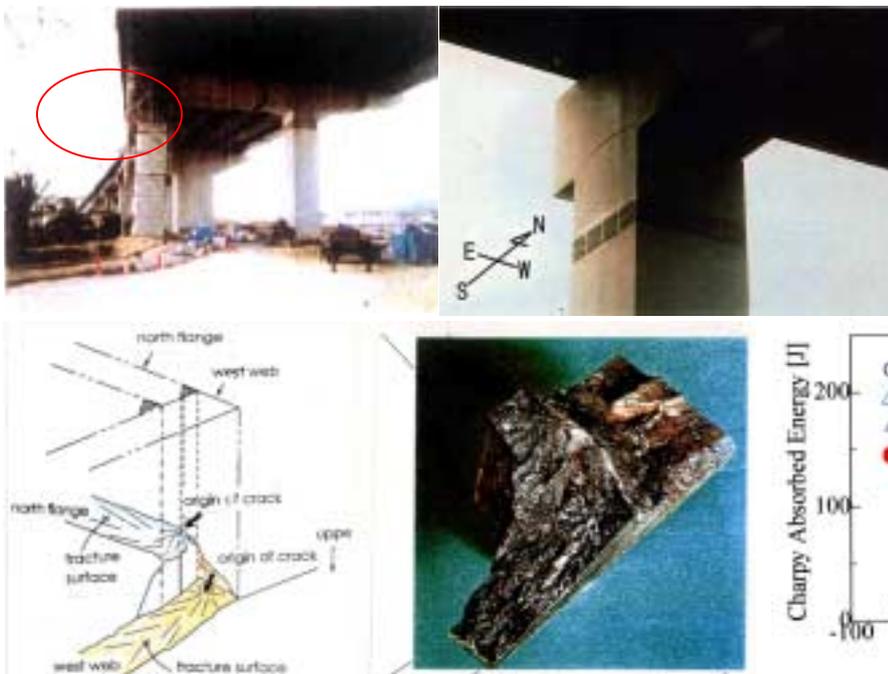
One of the important events of the Great Hanshin Earthquake was the occurrences of brittle fractures in steel bridge structures. A brittle fracture accident during the earthquake occurred in one of the steel rigid frame bridge piers called P75 in the Harbor Highway (Figure 5). Cracks started from the lower corner of the beam and the column shaft, and ran through almost the entire cross section of shafts. The Chevron pattern on the failure surface indicated that the cracks started at the west-north corner of shafts and propagated into both the north flange and the west web plate.

Detailed observations at the crack originated portion revealed that the cracks started from the unwelded-zone at the corner of column-beam connection, so-called delta-zone (see 3.3). There were two origins of crack, one was the toe of fillet weld on the north flange which was the origin of cracks propagated into the flange plate and another was just inside of fillet weld end on the web plate which was the origin of cracks in the web plate. The observations of fractographs indicated dimple patterns were remained in these areas and the sizes of these were about 0.7mm and 0.4mm. Outsidess of these areas are typical brittle fracture surfaces.

Figure 5 Brittle Fracture in P75 Rigid Frame Pier

fracture was the result of large plastic deformations at the corner due to shear lag during the earthquake and the deterioration of fracture toughness due to plastic strain. The large unwelded zone “delta zone” existed at the high stress region and the small weld defects acted the origin of brittle cracks.

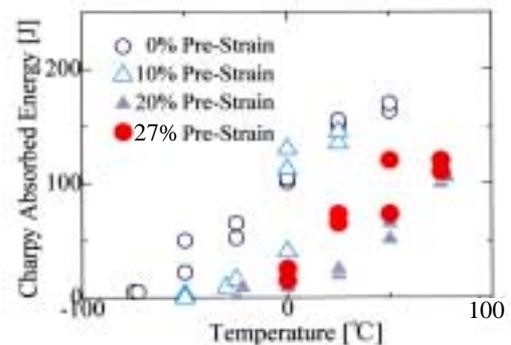
Figure 6 Results of Charpy Impact Tests

The used steels of this structure are SMA41 (SMA400). The tensile properties and the chemical composition satisfy the JIS requirements. Figure 6 shows the results of Charpy impact tests. Specimens were from the south flange plate of the shafts. In order to examine the deterioration of notch toughness due to plastic strain experience, specimens with pre-strain of 10%, 20% and 27% were tested beside as cut-out specimens. These test results indicate that notch toughness decrease significantly with increasing the experience of plastic strain.

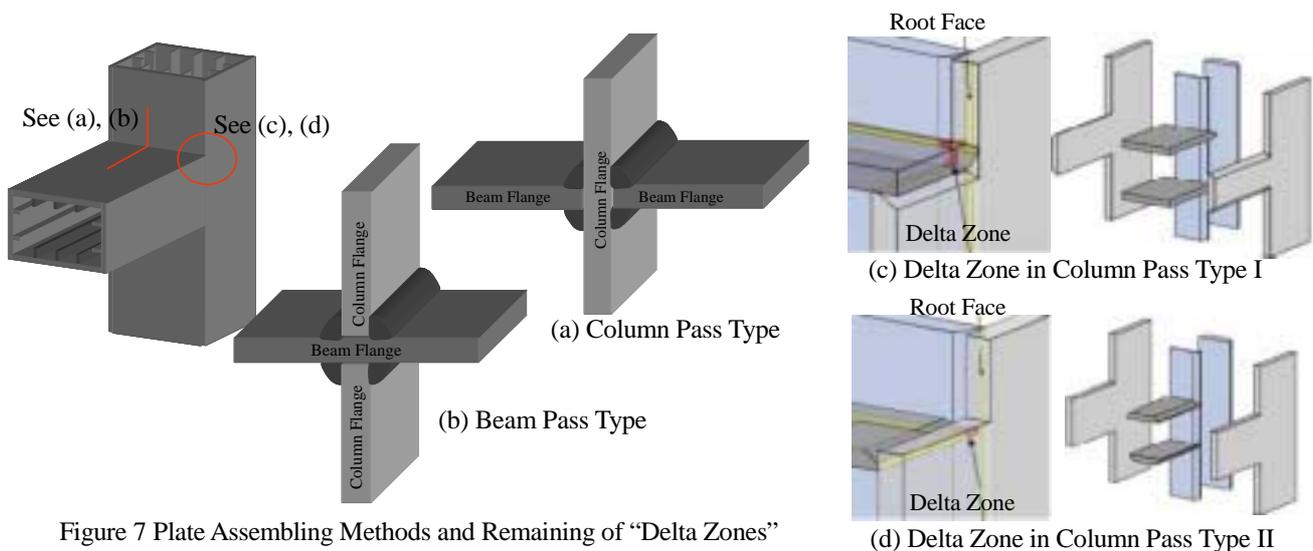
The steel bridge rigid frame structures consist of box section or cylindrical column shafts and box section beams, all of these members are welded closed sections. Figure 7 shows the details of plate assembling of beams and columns. The structural details are roughly classified into two types, one is column pass type and another is beam pass type (Figure 7(a), (b)). However, plate assembling system are more various and complicated.

Detailed investigations of fatigue damaged piers in Tokyo Metropolitan Expressway revealed that un-welded cavities and metal-touch zones existed at the corner of beam to column connections. In most cases, these are kind of inherent defects coming from plate assembling system, poor accessibility and improvident welding sequences. Figure 7(c) and (d) show the remaining of delta zones in two different column pass type plate assembling methods. We call these inherent defects as “delta zones”. The delta zone is the dominant cause of fatigue cracks in many steel bridge piers and also may lead to brittle fractures in the case of suffering strong earthquakes. The combination of existences of delta zones and fatigue cracks more increases the possibility of the occurrence of brittle fracture.

Figure 7 Plate Assembling Methods and Remaining of “Delta Zones”

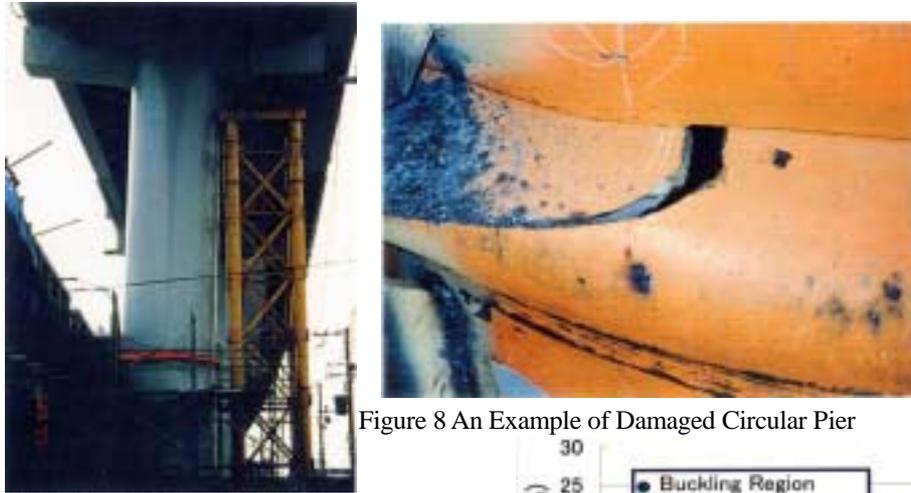
In cylindrical steel bridge pier shafts on the Kobe route of Hanshin Expressway, there were cases where plastic deformation occurred and the wall of pier shafts bulged outward, so-called “lantern buckling”(Figure 8). The sections where lantern buckling occurred were close to the welded joints where the plate thickness was changed. Once these buckling incidents occurred, the load bearing capacity for supporting vertical forces became lost significantly.

Brittle fractures also occurred along the outward plastic deformation in two consecutive pier shafts. One of the pier shafts had exhibited large plastic deformation outward but the plastic deformation was not so large in another pier shafts. The crack seemed to start from the inside of shaft wall.

Figure 8 An Example of Damaged Circular Pier

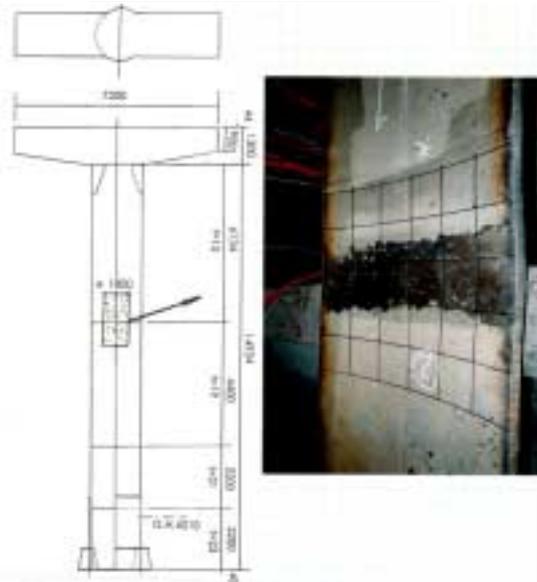
Figure 9 shows the plate cut out from one pier which was suffered lantern buckling. Various

Figure 8 The Steel Plate Cut from the Damaged Pier

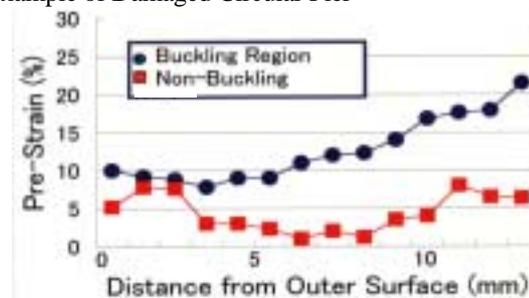
material tests were performed on specimens made from this plate. Figure 10 shows estimated plastic strain in the plates from buckled zone and unbuckled zone. The plastic strain on the inner surface of column wall is over 20%. This plastic strain caused deterioration of toughness of the plate, called embrittlement, as shown in Figure 11. Embrittlement due to plastic strain, particularly compressive strain becomes new problem for us to prevent the fatal condition of bridge piers.

Figure 10 The plastic strain distribution in the plate thickness

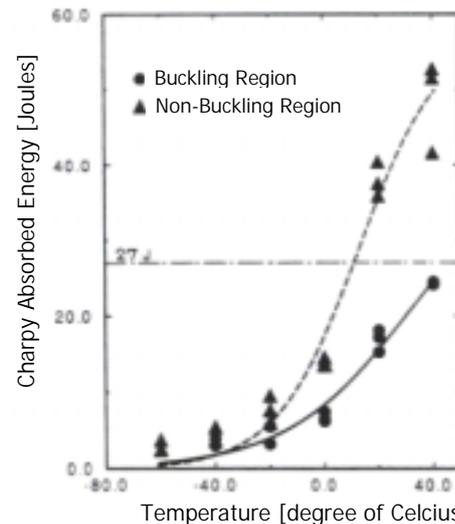
Figure 11 The Charpy impact test results of the steel plate

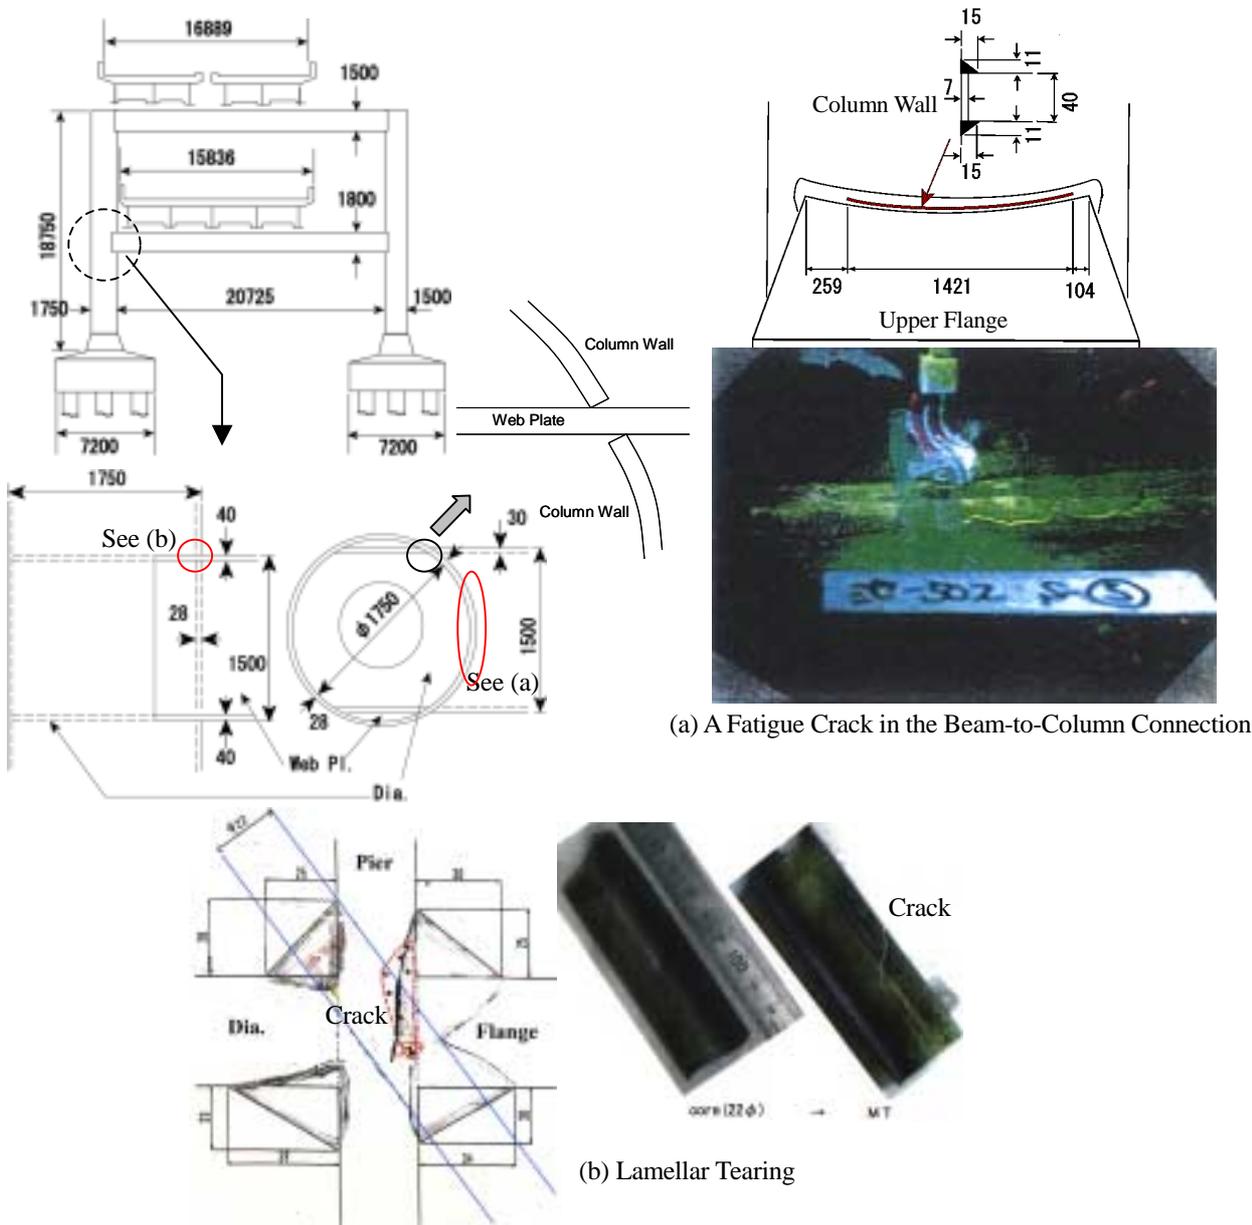
(a) A Fatigue Crack in the Beam-to-Column Connection

(b) Lamellar Tearing

Figure 14 The Fatigue Crack and Lamellar Tearing during Retrofitting Works by Welding in a Steel Bridge Pier
