FRACTURE IN STEEL BRIDGE PIERS DUE TO EARTHQUAKES

Abstract: The great Hanshin Earthquake of January 17, 1995 caused serious damage to various civil structures never before experienced. A particular emphasis is placed on the fracture in steel bridge piers, and the results of studies up to date are reviewed in this paper.

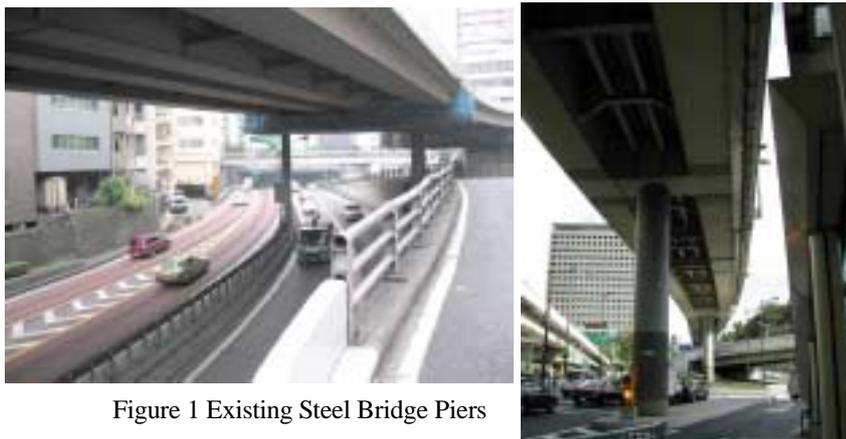
Figure 1 Existing Steel Bridge Piers

Steel bridge piers have been adopted to support elevated highways and over pass bridges. Particularly, the piers of expressway in urban areas are in the median strip zones or sidewalk zones of streets because these are placed on the existing streets and piers (Figure 1). There are more than 5000 piers including 2000 piers in Tokyo Metropolitan Expressway and some of these are decrepit. Fracture accidents in these structures during earthquakes may cause not only the service failure of expressways supported by these piers but also a muddle on streets underneath the expressway.

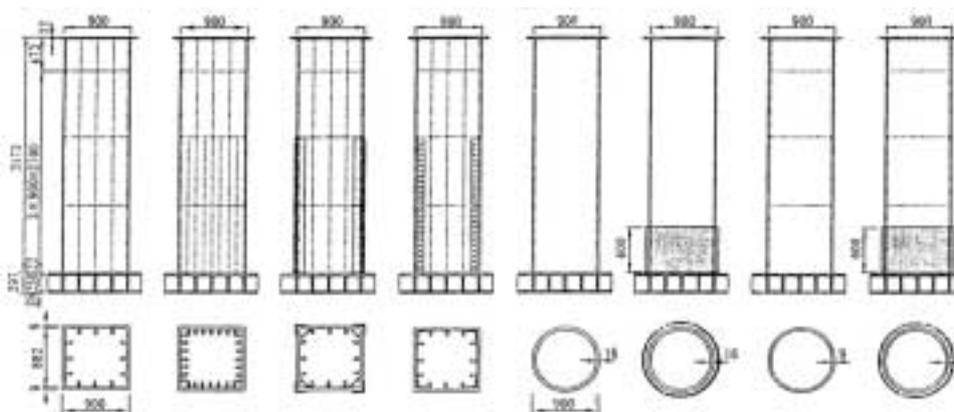
Figure 3 Specimens of Steel Bridge Piers

Figure 3 shows the some of specimens in the cooperative study under the Public Works Research Institute. In order to improve the seismic performance of steel bridge piers and develop retrofitting methods for existing structures, 99 large size column type specimens were tested in total under incremental repeating loads and hybrid response loads.

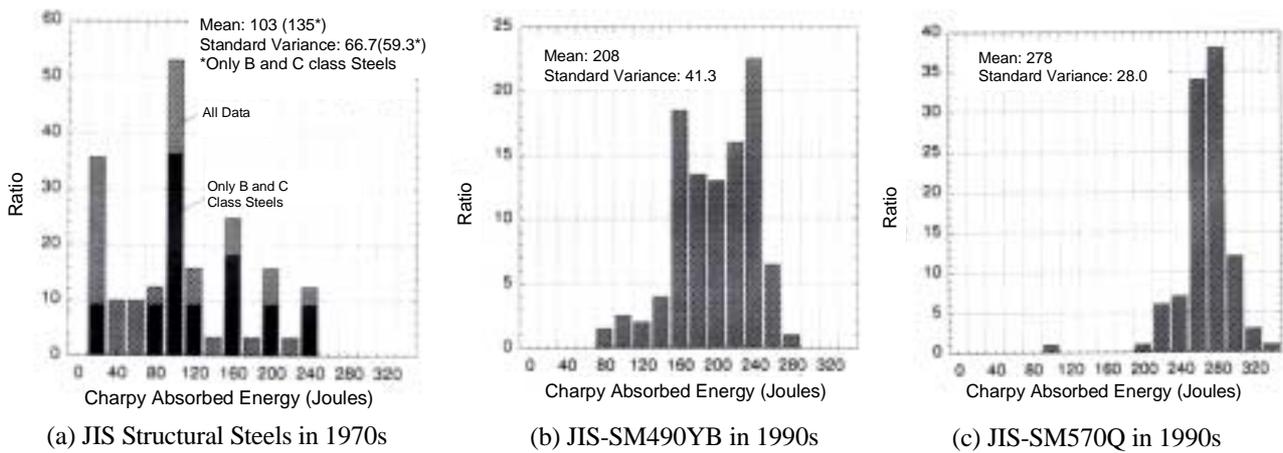
Figure 12 Distribution of Charpy Absorbed Energy of Steels Produced in 1970s and in 1990s

Figure 12 shows the results of Charpy impact tests in 1970s and 1990s. The notch toughness property of steels was significantly improved (K. Honma, C. Miki et-al, 1997). We also have to recognize that the fracture toughness of old steels is low in some cases.

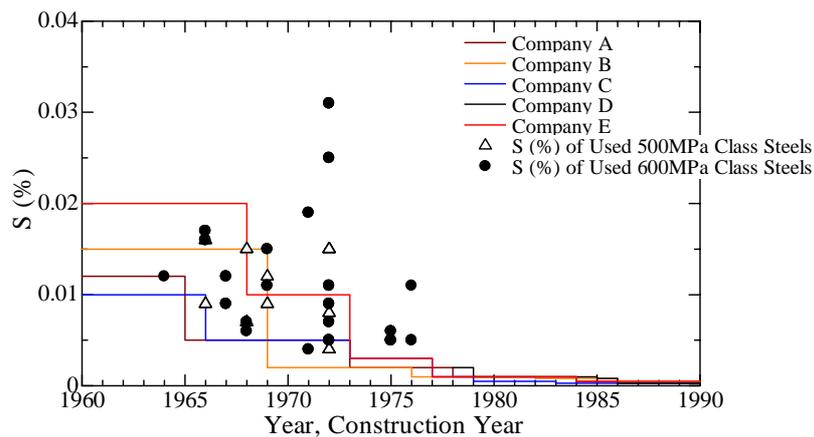
Figure 13 History of Sulfur Inclusion in Steels

Figure 13 shows the transition of capability for removing sulfur (S) from steels. All of steel making factories of the 5 major Japanese steel companies started to produce low S content steels since the middle of 1970s and the content of S in the recent steels is around 0.005%. However, the content of S in steels which were produced before the middle of 1970s might be over 0.01%. The high content of S leads to poor weldability and the occurrence of lamellar tearing in welded joints. In order to prevent the occurrence of lamellar tearing (Figure 14), the reduction of area in the plate thickness direction tensile tests (RAZ) have to be greater than 35%, and the content of S has to be less than 0.005%. That is to say, there is high risk of lamellar tearing in piers which were constructed before 1975. There are about 2000 steel bridge piers only in the Tokyo Metropolitan Expressway System and a half of them were constructed before 1975. We have to pay careful attention to the prevention of lamellar tearing in the retrofiting works against fatigue and earthquakes.
